# USCID

U.S. Committee on Irrigation and Drainage

Spring 2025  
Issue No. 1007

## Synthetic Canal Lining Evaluation Project

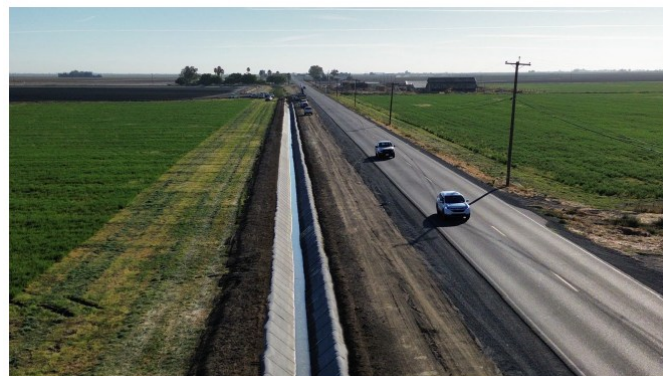
Figure 4. Completed canal section

The material was thermally bonded, and the seams screwed together with stainless steel screws. At the end of each day, the material that had been installed was fully hydrated. This is an important step in installing GCCM. It prevents partial pre-hydration resulting from unexpected rainfall or even heavy dew. If this were to occur, the upper most part of the concrete layer would cure, leaving concrete powder between the cured layer and the underlying geomembrane. While the entire layer would eventually cure, during that time, the GCCM would not exhibit the strength or durability of a fully hydrated and cured GCCM that was expected. The installation of 28,000 sf of GCCM on this ¼ mile section (1,440') of canal took 3.5 days (Figure 4).

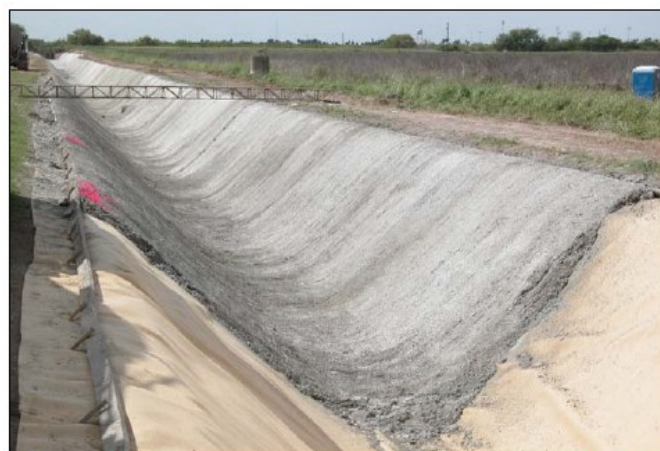
Figure 2. Polyester canal liner with a 3-inch protective barrier

reduces seepage losses dramatically, while the layer of shotcrete prevents damage to the liner. Five projects extending over about 17 miles were implemented using this system with two different liners: polyester and PVC. The protective barrier consisted of 2 - 3 inches of shotcrete as shown in Figure 2.

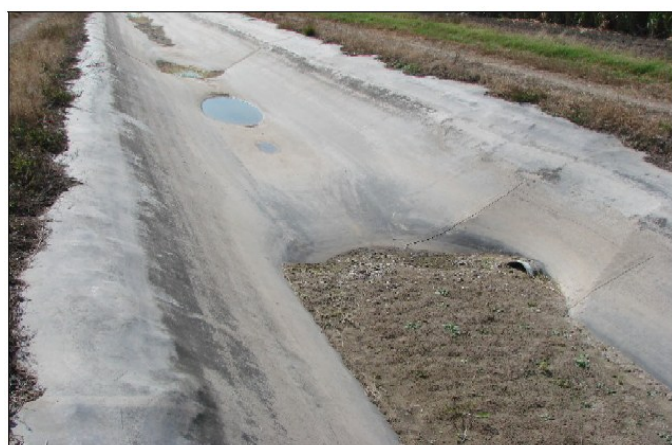
Figure 3. Aquatic vegetation and sedimentation clogging a farm outlet pipe

Installation and maintenance of the liners also appears to explain some of the variation in performance of these projects as discussed below. Another consideration with exposed liners is the potential damage that machinery can cause during normal district mowing operations and while cleaning out aquatic vegetation and sedimentation (Figure 3).

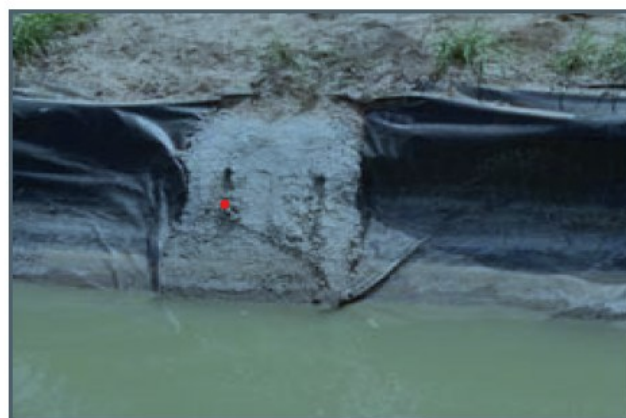
Figure 4. Concrete sections poured on top of a polypropylene liner

**Polypropylene** In two lining projects, polypropylene was applied on existing concrete canals. To-date, these two lining projects are in excellent condition, with no visual damage. Yet, for one of these projects, we have concerns with the large amount of wrinkles which occurred during installation. Wrinkles can reduce water flow, accelerate sedimentation, and provide loose material that can easily be damaged.

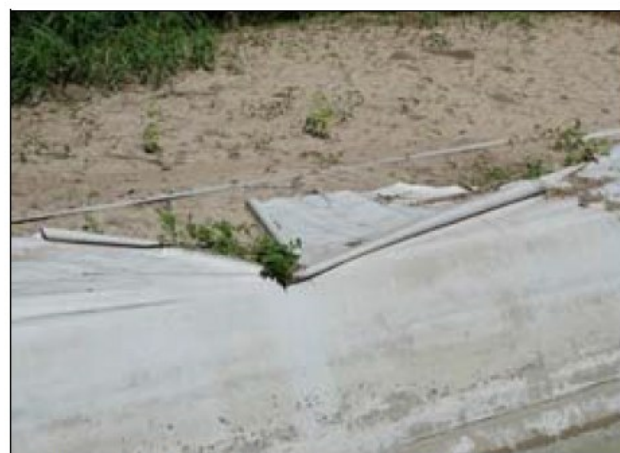
Figure 5. PVC Alloy liner damaged on the exposed area

**PVC Alloy** Three short sections of PVC alloy were installed in 1999, ranging in length from 38 to 148 ft. This material has performed well, requiring little maintenance, with no major damage observed. However, cuts and tears have occurred in the exposed area of the liner (Figure 5) which could develop into larger problems if not taken care of in a timely manner. The overall performances for these small test segments are excellent to good.

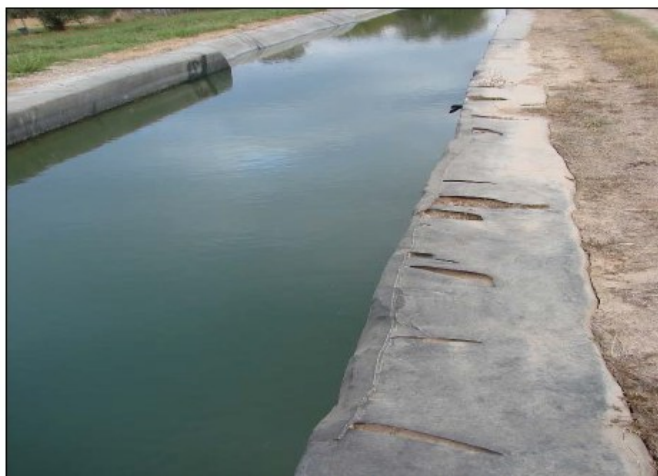
Figure 6. Cuts/tears in a rubber liner

initially occurred on the exposed areas where there is the most human and animal traffic (Figure 6). Unless repaired in a timely manner, these tears may lead to increasing amounts of damage (Figure 7).

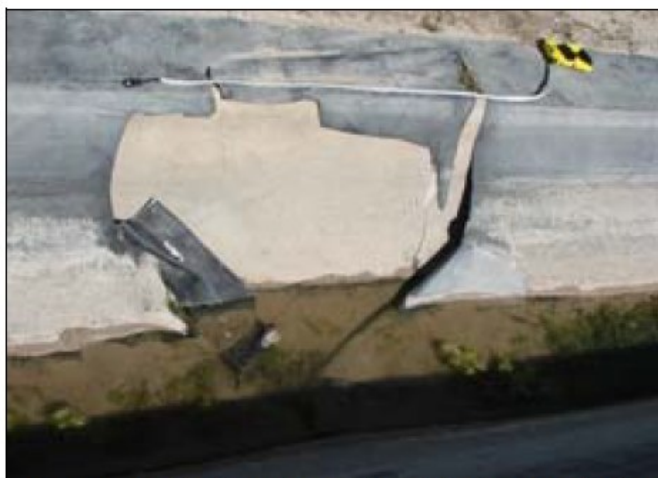
Figure 7. A rubber liner damaged possibly due to vandalism

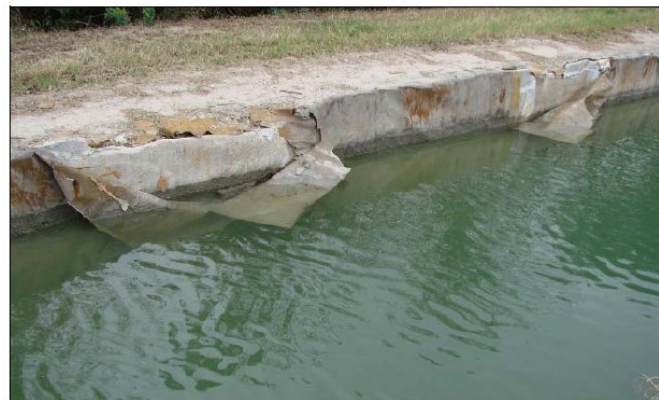
Figure 8. Polyurethane liner is shown hanging off the canal wall.

**Polyurethane** During 1999 - 2000, nine short sections were lined with polyurethane, totaling 1.42 miles. The current condition of these projects varies from excellent to serious problems, with one section a total failure. Observed problems include the liner falling off the canal walls which was likely caused by a combination of severe UV damage (Figure 8), material defects, and vandalism. In some segments, the top layer of the material has peeled off, while in others, the entire liner has worn off (Figure 9).

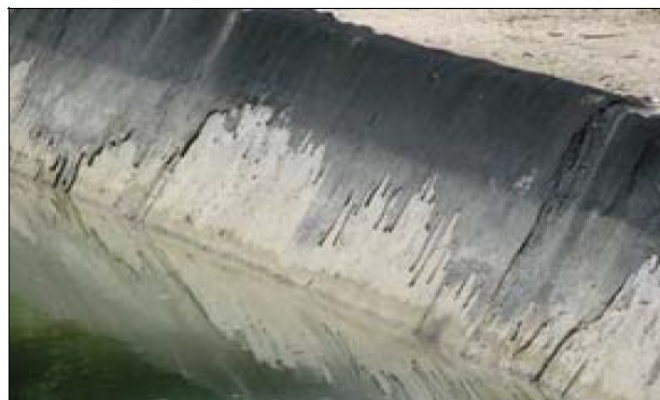
Figure 9. Residue left from a deteriorated polyurethane liner

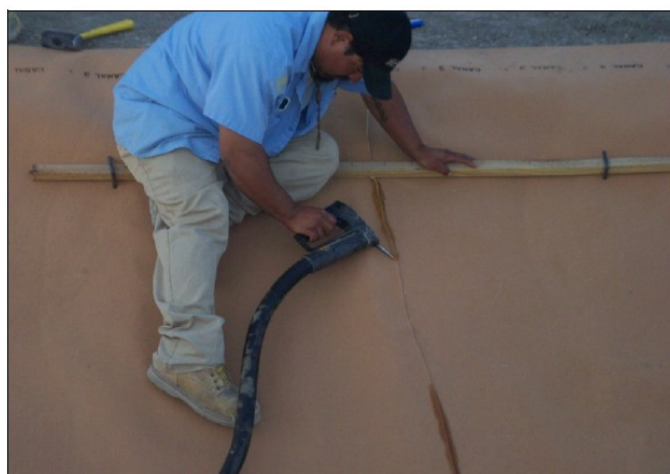
Figure 10. Glues being applied to the joints of a polyester liner.

Liners need to be properly installed and stretched in order to prevent wrinkles. Wrinkles not only look unprofessional, but make the liner more susceptible to damage. Glues, liquid rubbers resin, tar and types of metal pins are used to secure the material around the structures and at the joints (Figures 10).

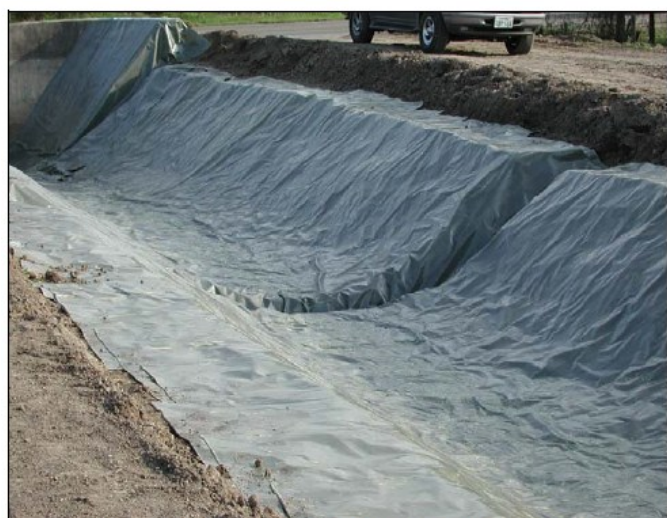
Figure 11. Canal liner installed too low on the levee

In one of early lining projects, the liner size was not planned properly to overlap and extend onto the top of the levee (Figure 11). As seen in Figure 12, the operating depth of the canal was higher than the top of the liner. The water eventually got underneath this liner and caused it to float.

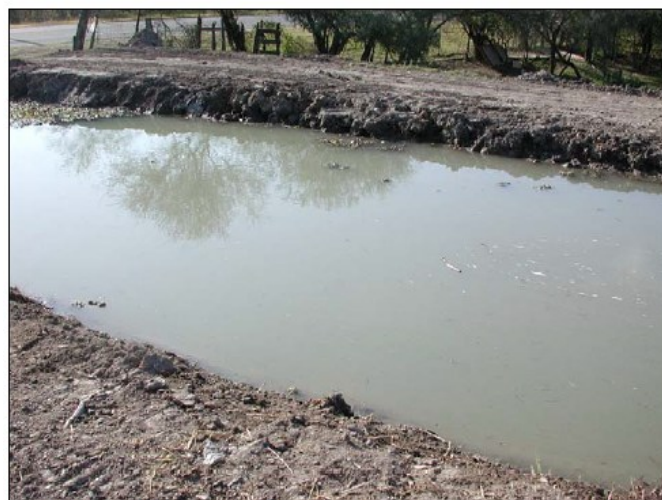
Figure 12. Water level higher than the canal liner installed

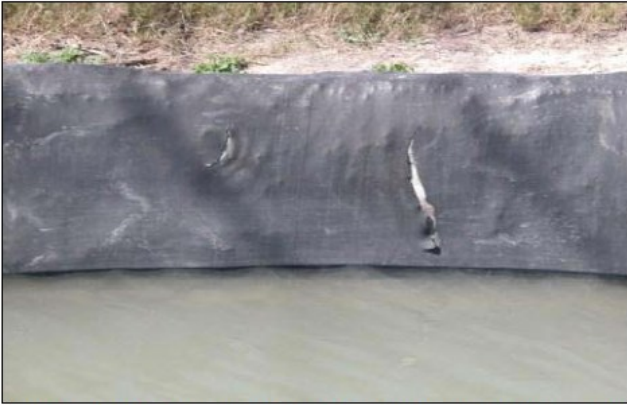
Figure 14. Vertical cut or tear on canal side wall caused unintentionally

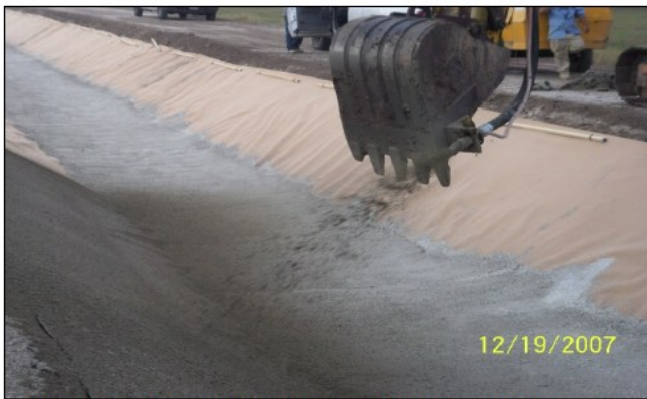
Figure 15. Shotcrete being sprayed onto the fibrous polyester liner

While the initial costs of a lining project using a use of a protective barrier such as shotcrete are higher, these costs may be offset by the reduction in costs of maintenance and repairs over the life of the project. An important consideration is the ability shotcrete to adhere to the liner. The polyester material has small fibers (similar to the harden side of Velcro) to which the shotcrete will stick when sprayed on to the liner (Figure 15). On the other hand, the PVC liner has a smooth texture to which the shotcrete will not stick, and a wire mesh needs to be used on the top of the liner to provide grip and added reinforcement. This application also increases labor and cost.

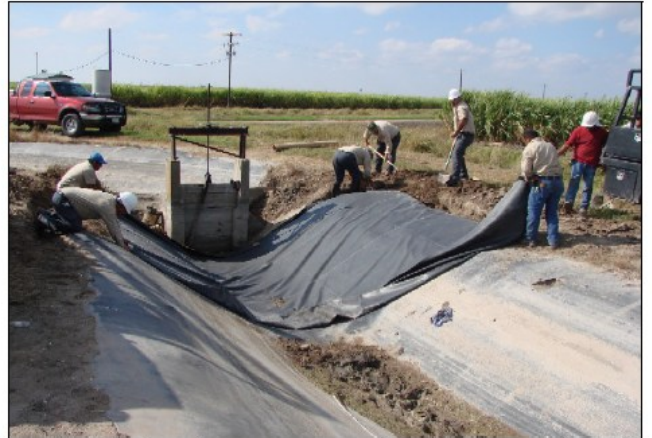
Figure 16. A district maintenance crew repairing a damage section of lining

similar glues and adhesives used during the installation process (Figures 16 and 17). Removing sediment from lined canals may be more difficult due to the limitations of using heavy machinery, and may require increased manual labor (Figure 18).

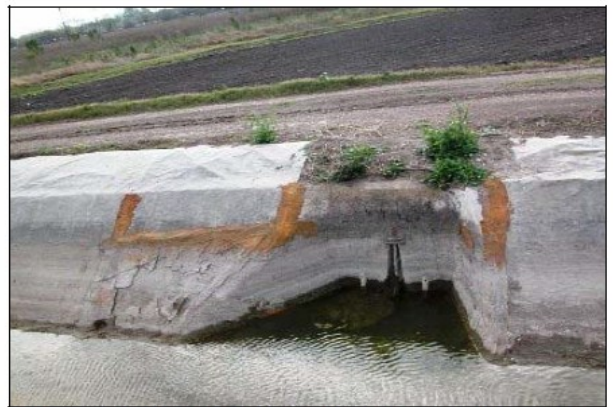
Figure 17. Repair of the liner joints around a structure with glue

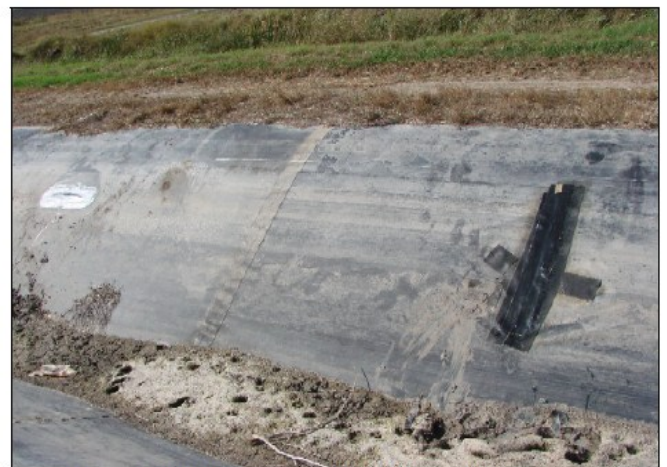
Figure 18. Sedimentation at the bottom of a lined canal

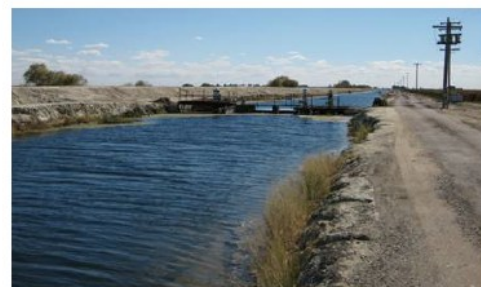
Figure 2. James ID Main Canal during pre-compaction seepage test.

- The entire canal pool that was compacted was filled with water to the normal operating depth.
- The ends of the pool were sealed to prevent water from entering or leaving the pool.
- Weather data was recorded from the nearest CIMIS station, to estimate evaporation losses.
- Redundant water level sensors were installed to measure the change in water depth versus time.
- The water was replenished occasionally with a metered supply to maintain a fairly constant water level.
- Water temperatures were measured, to correct for different viscosities in pre- and post-compaction tests.
- Measurements began after water had been standing in the pool for several days, and continued for 1-3 days.

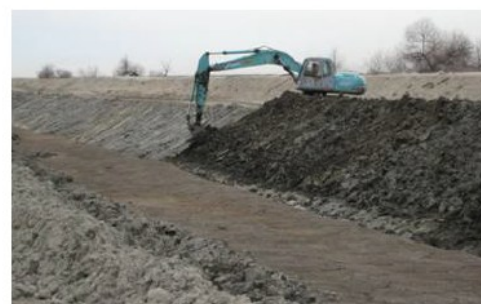
Figure 3. James ID Main Canal during side compaction

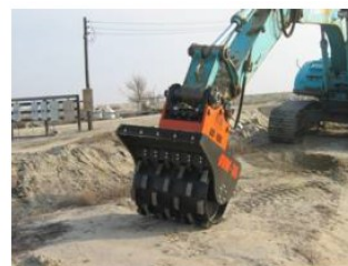
Figure 5. MBW 36" vibratory roller attached to the end of an excavator arm.

sides of 1 mile of canal (both sides, meaning 2 miles total) in about 8 days. The cost for the operator, transport of the excavator, and the excavator rental was about \$1.20/foot of canal, with about 10 feet of compaction on each side of the canal (cost = \$1200 for 1000' long pool).
